Client: **FL National Guard - Dept. of Military Affairs**
Starks, FL
 Project Name: **Cooper Hall Renovation at Camp Blanding Joint Training Center (CBJTC)**
 Drawing Name: **Roof Framing Plan & Details**

Drawing No. **S3.01**

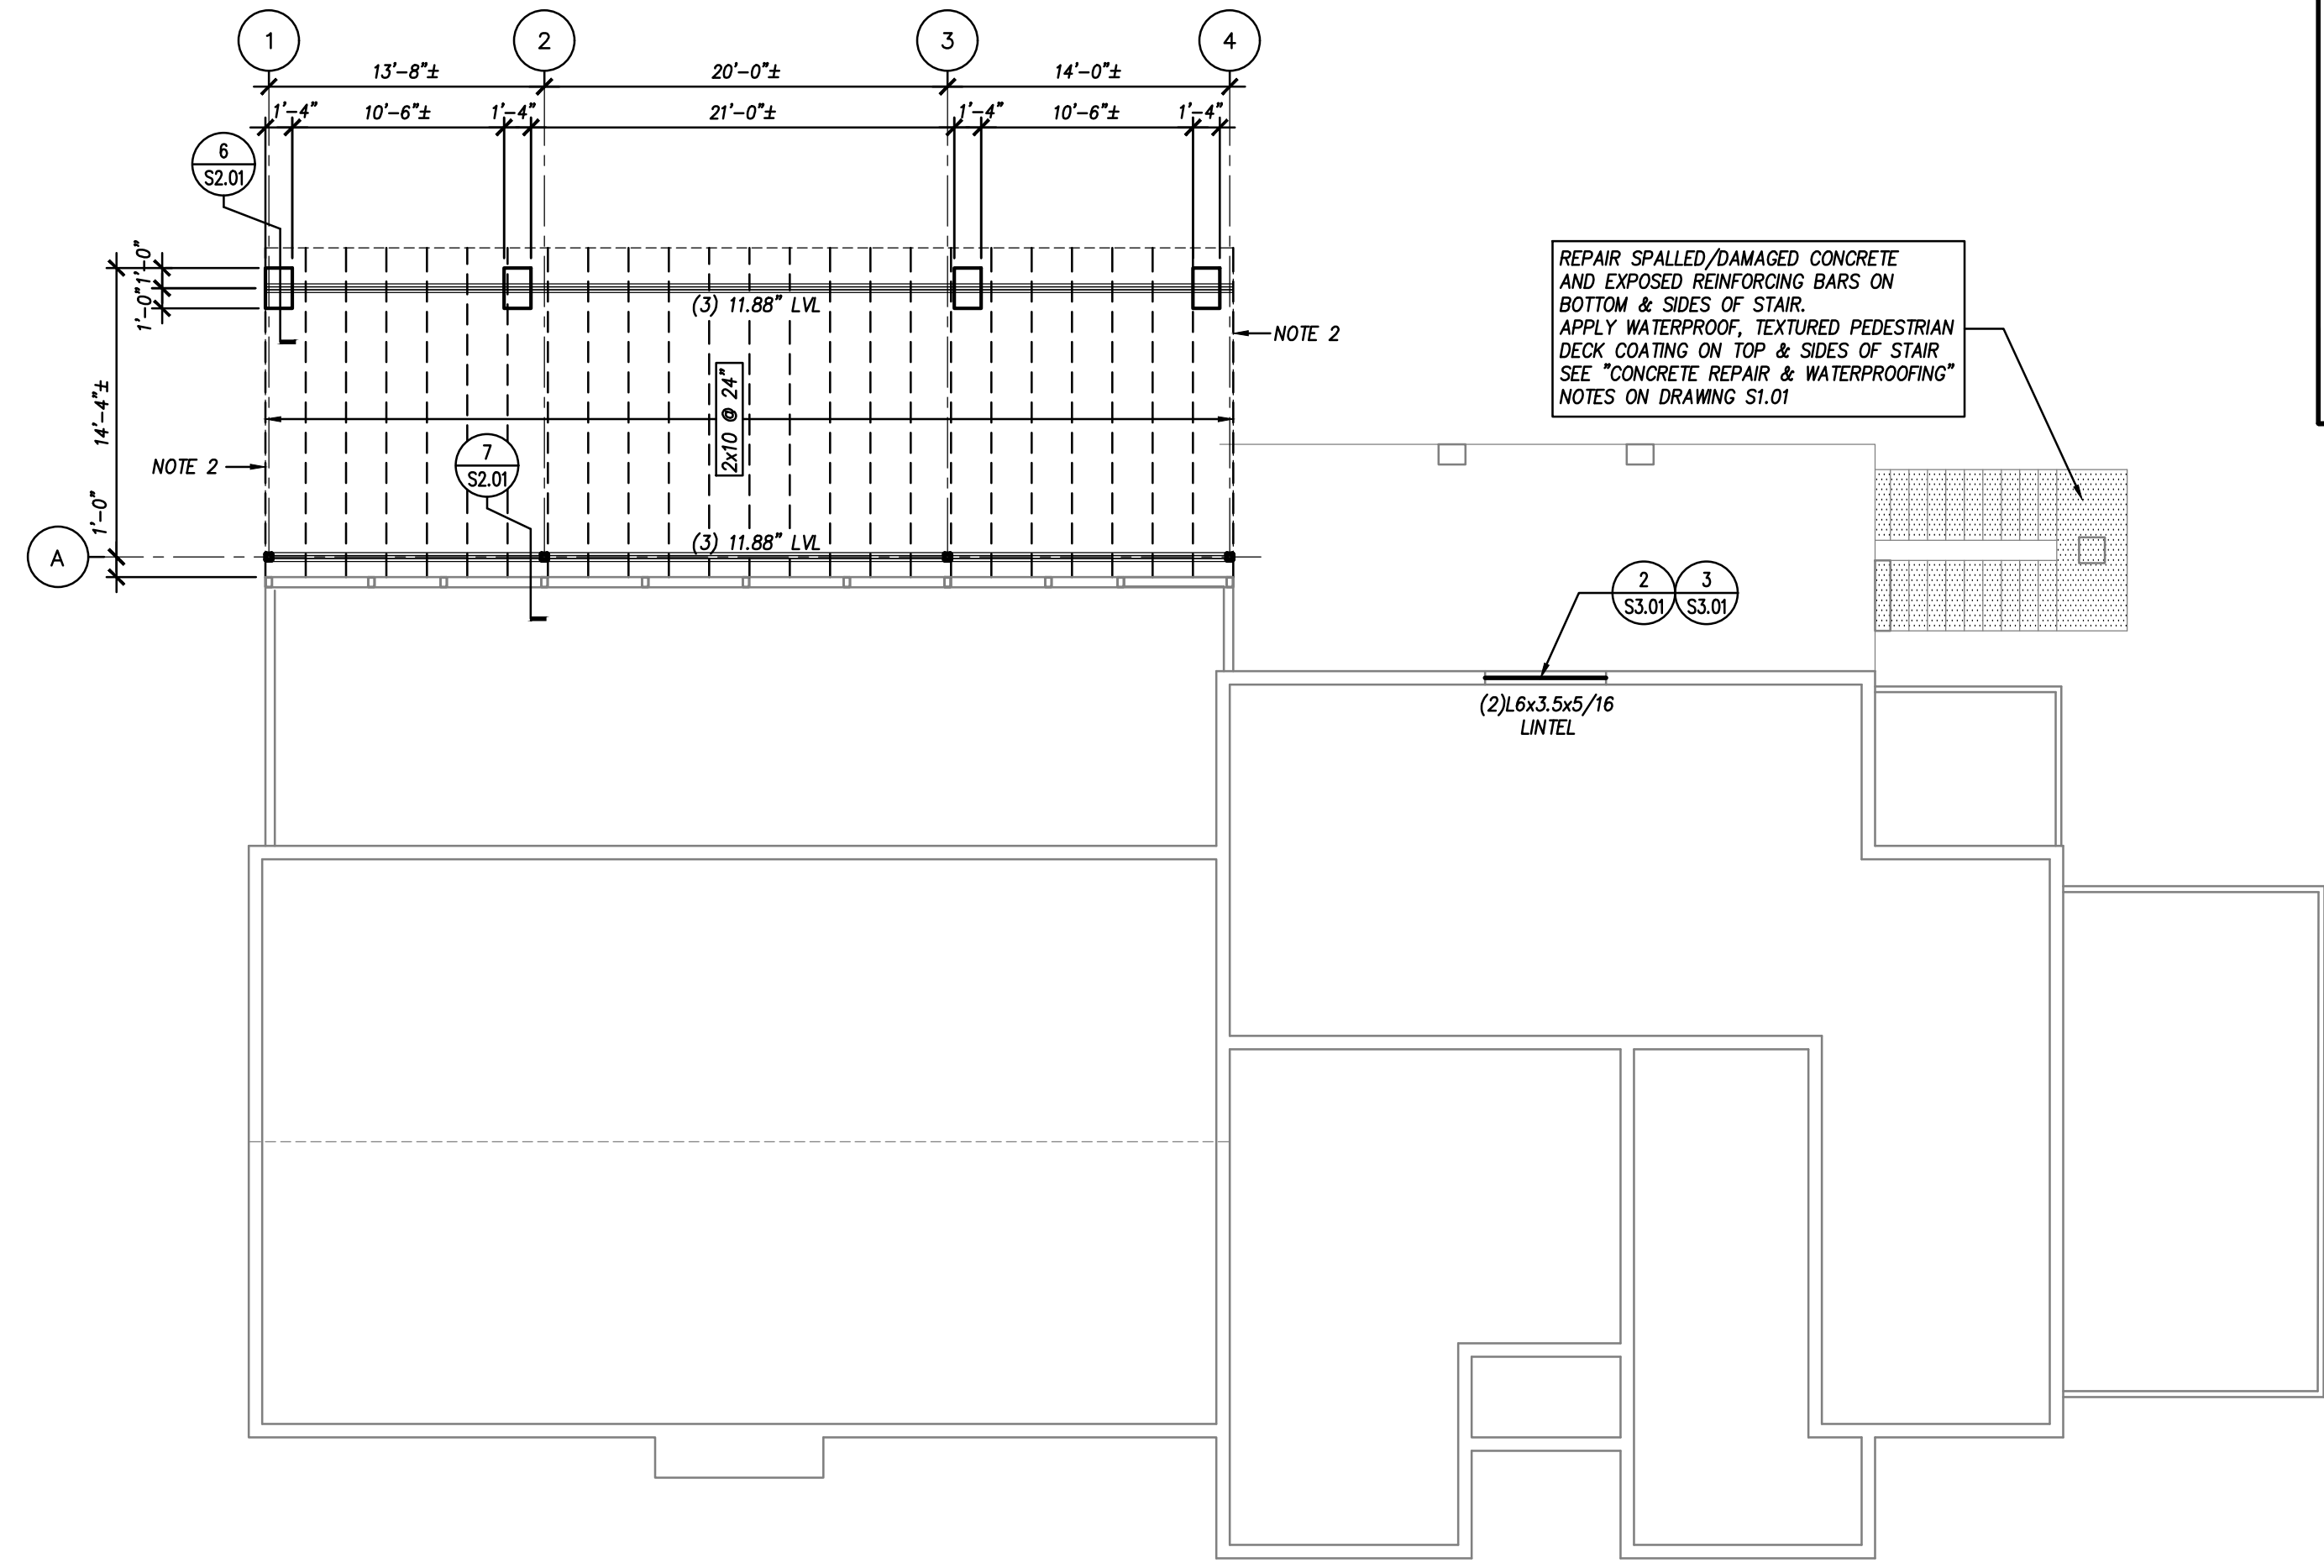
1 Roof Framing Plan

1. ALL EXISTING CONDITIONS AND DIMENSIONS SHOWN AS ± SHALL BE CONSIDERED APPROXIMATE AND SHALL BE FIELD VERIFIED BY CONTRACTOR PRIOR TO BEGINNING CONSTRUCTION.
2. FIELD SET LOCATION OF EDGE OF ROOF TO MATCH EXISTING.
